CORANGAMITE  
SHIRE

# Lake Bullen Merri Management Plan

DECEMBER 2017

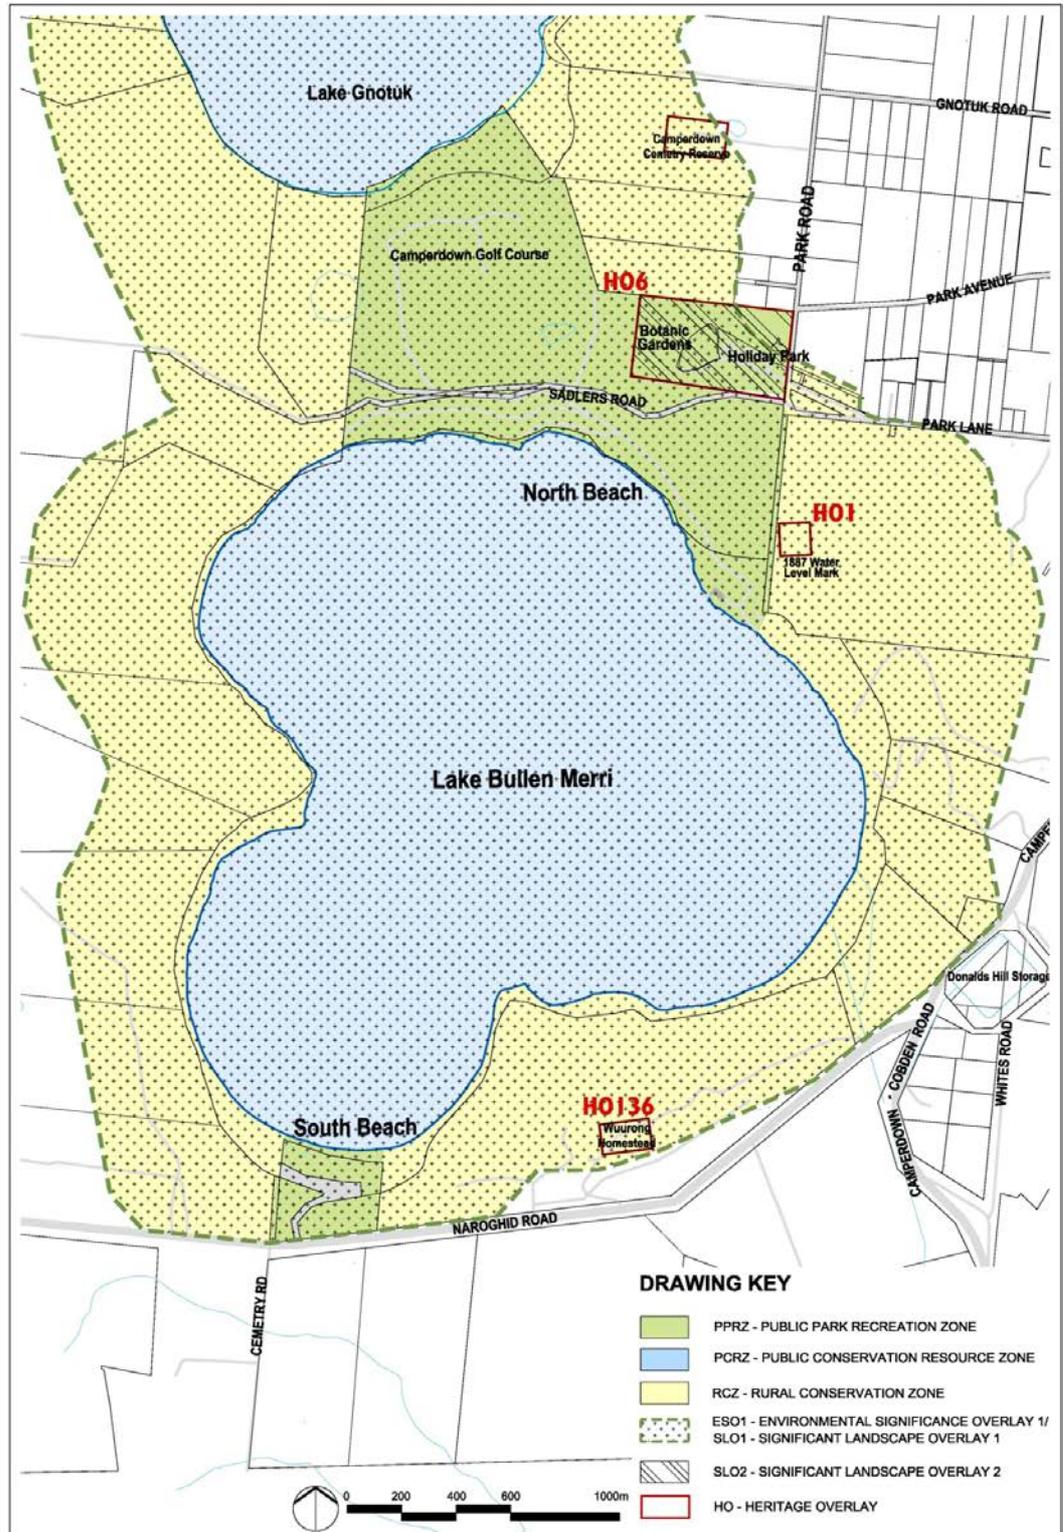
**Figure 3 – Existing Planning Controls (Corangamite Shire Planning Scheme)**

- Schedule 1 (SLO1) This overlay applies to the same area as the ESO1. The overlay aims to protect the landscape values at Lake Bullen Merri.
- Schedule 2 (SLO2) This overlay applies to the Camperdown Botanic Gardens. The overlay aims to protect the landscape values of the Botanic Gardens.

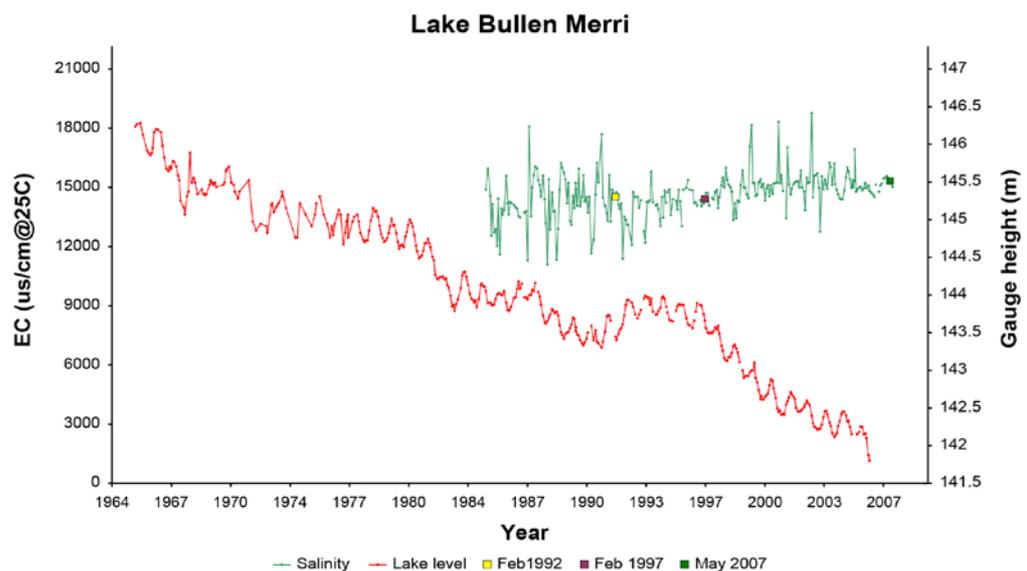
**Figure 5 - Historical lake level and electrical conductivity (Leahy et al. 2010)**

It is predicted that the water levels in the lake will reach an equilibrium that is much lower than the current depth. However the large volume of water in the lake means it will take hundreds of years to reach the equilibrium water level. (Leahy et al. 2010).

The lake water level is currently falling on average 10-20 centimetres in depth annually under typical rainfall and evaporation conditions. This equates roughly to a shoreline change of 2-3 metres annually on the current South Beach shoreline profile but less on the steeper sections of North Beach.

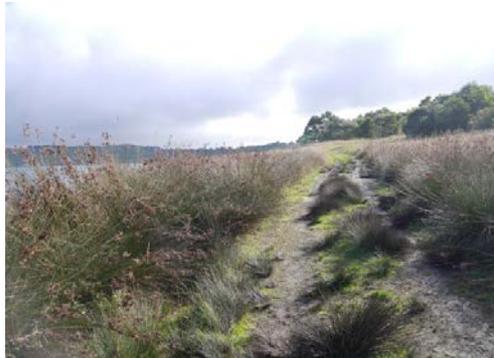
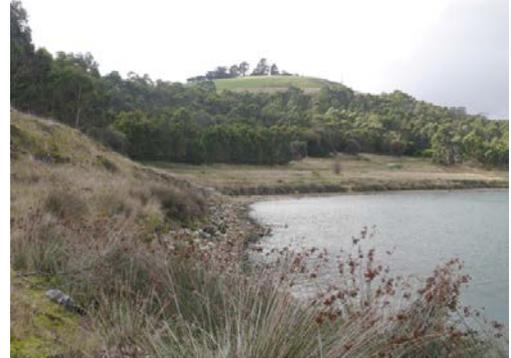
*Photo 2 and 3 - Spiny Rush infestation at North Beach*

There is extensive infestation of Spiny Rush *Juncus acuta* along the shoreline at North Beach. *Juncus acuta* is a declared noxious weed (DSE 2008) and is regionally controlled. Once established it completely covers shoreline areas excluding all other vegetation with

sharp spines that also restrict access to water. At South Beach the shoreline is free of Spiny Rush however shoreline areas require ongoing herbicide control to prevent establishment as water levels recede. The southern section of South Beach at the top of the crater is infested with *Pittosporum* sp.

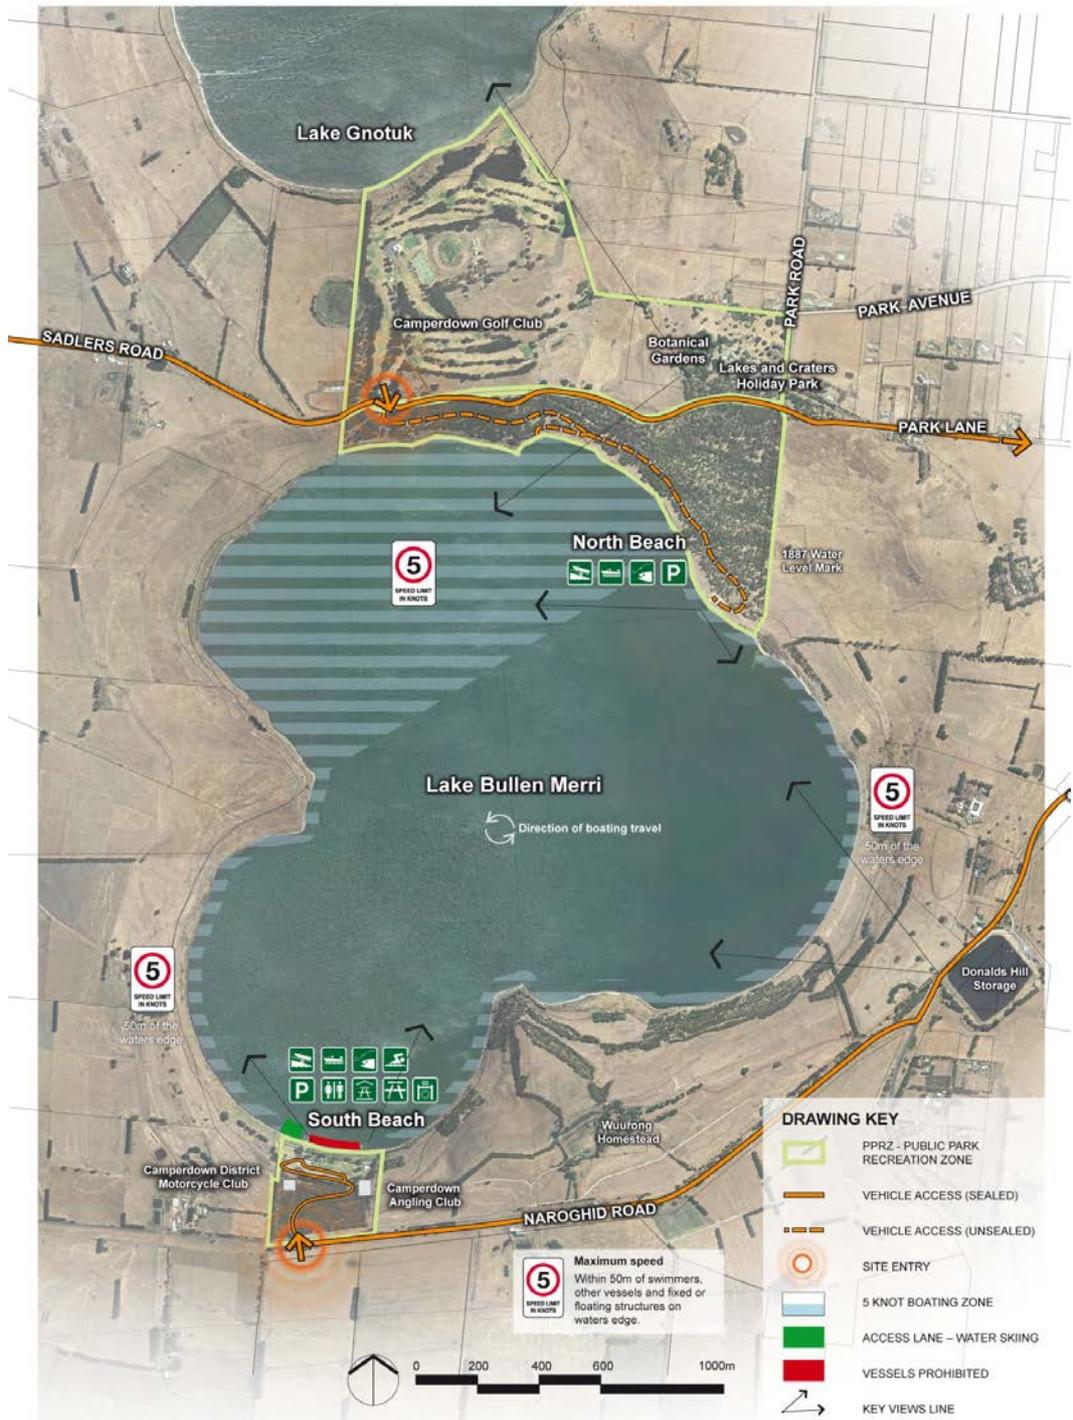
Figure 8 – Existing Lake Bullen Merri Recreation Facilities and Access

There are two publicly accessible Crown land reserves adjoining Lake Bullen Merri — North Beach and South Beach. South Beach is a popular destination for a range of recreation activities including fishing, waterskiing, jet skiing, sailing, picnicking and swimming. North Beach has a more natural aspect to the lake with limited facilities suitable for local fishing and walking. Refer Figure 8.

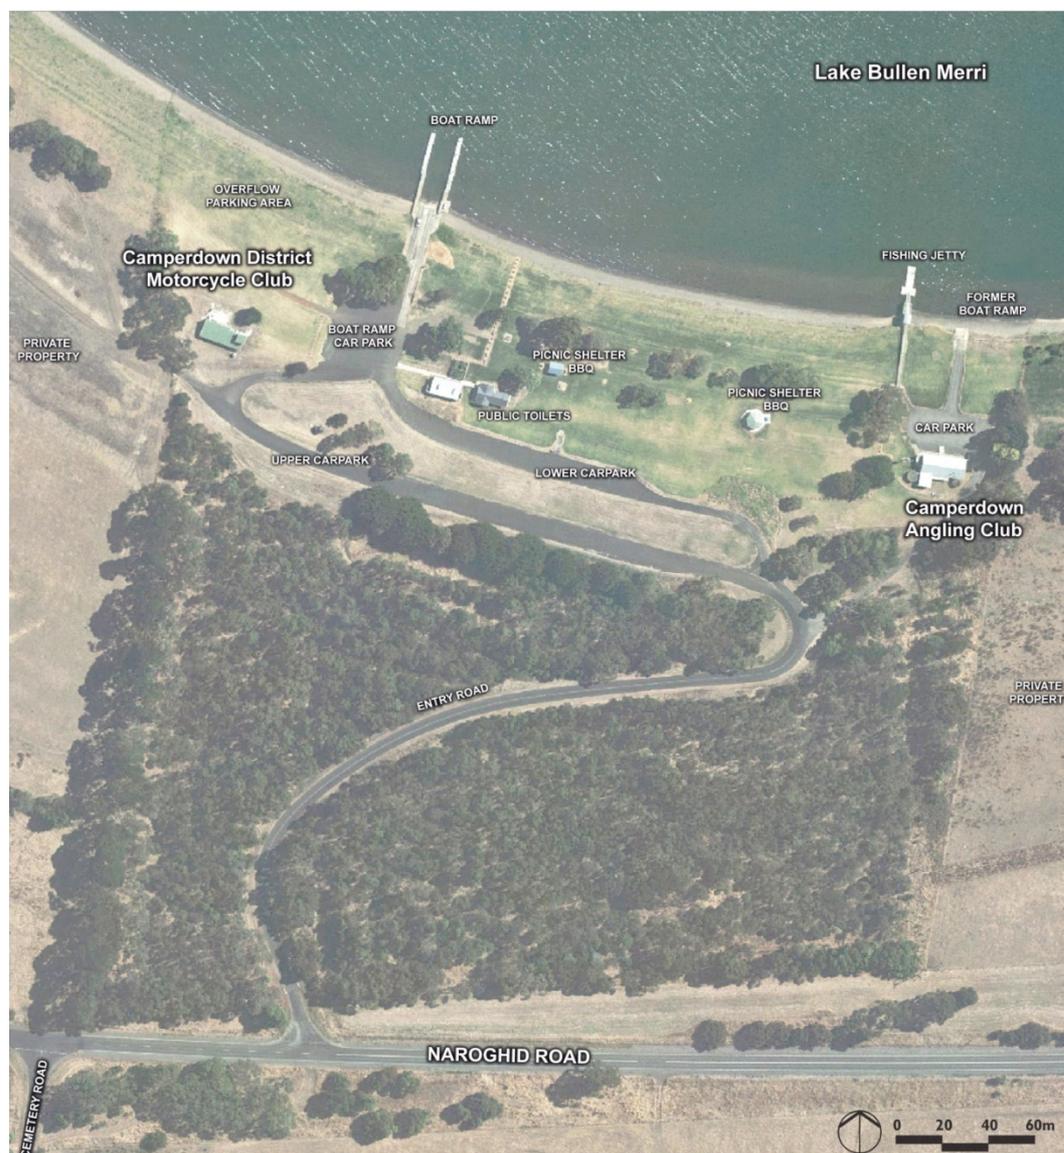
**Figure 9** –South Beach Existing Conditions

The Camperdown Angling Club car park is unsealed is located on the north and south sides of the club building. The club has indicated they would like to seal the car park in the near future.

The grass bank on the lake side of the Camperdown District Motorcycle Club is used for overflow boat trailer and car parking on busy days. Shade annexes and other picnic facilities are often erected there during peak summer periods.

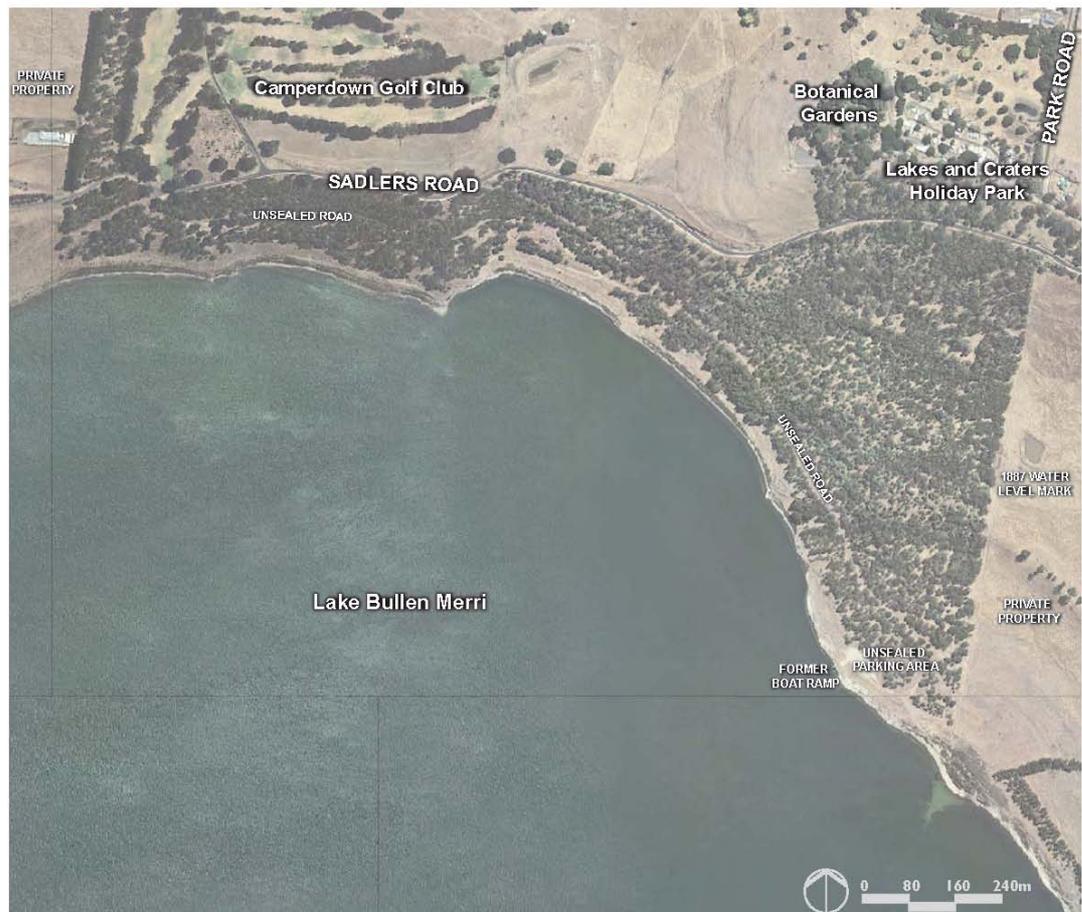
Figure 10 – North Beach Existing Conditions

- Informally established mountain bike tracks on the steep slopes run directly across the roads and tracks creating a public safety risk.
- Uncontrolled vehicle access to the north beach shoreline and informally established tracks impact on vegetation management and increase the transfer of sediment into the lake after rainfall.

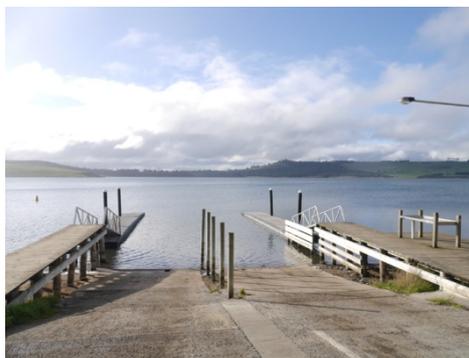
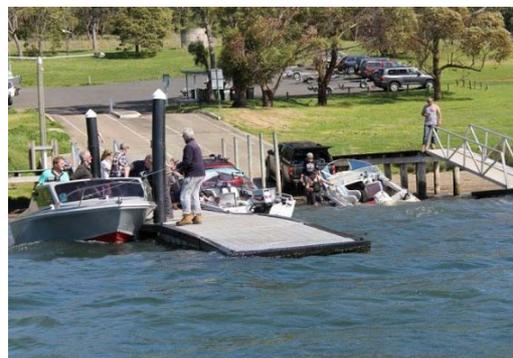
*Photos 12 and 13 South Beach Boat Ramp*

The surface and pontoons at the main boat ramp were upgraded and extended in 2011 and again in late 2015. This is a regular and ongoing requirement due to the declining water levels.

- Boat ramps and jetties and other edge of lake infrastructure require substantial modification or replacement every 5-10 years to remain safe and functional due to declining lake water levels (in the order of 10-15 cm/year).
- Access ramps to the pontoons also need to be extended and lowered in height to reduce the grade.

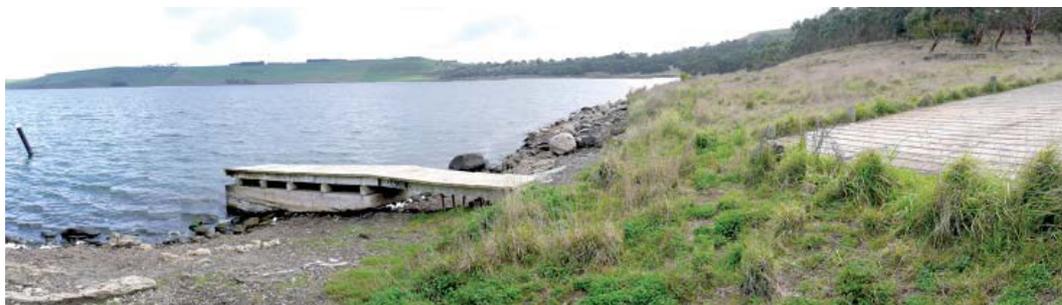
*Photo 14 Former North Beach Boat Ramp*

The boat ramp at the North Beach which was built in 1994 and is no longer functional and is subject to significant wave action under prevailing south westerly wind conditions. The inability to establish adequate piling in the rocky lake bed led to failure of the pontoons alongside the ramp.

A boat ramp located on the North Beach would help to provide alternative access in northerly winds and during peak times. Relocation of the boat ramp to a more suitable location on the North Beach may make the ramp easier to use and to continue to provide access to the lake. Road access to the ramp would also need to be upgraded to provide safe access for vehicles with trailers.
